# NABCO ENTRANCES TECHNICAL BULLETIN

Effective Date: March 29, 1999

## Modification for Radio Controlled Transmitters

Bulletin Number: **14**

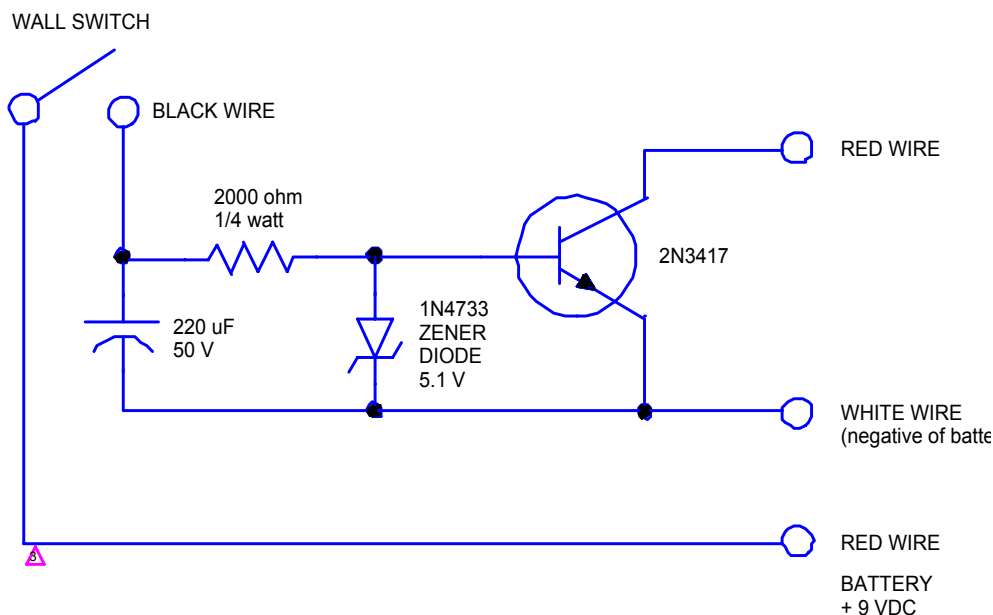
We have received reports of pulse extender boards having weak signals. As a result, they were not picked up by the receiver.

To strengthen the signal:

1. Remove the RED wire from the switch going to the pulse extender board.
2. Cut this wire off at the board.
3. Solder a wire onto the radio controlled transmitter board where the red battery wire is soldered.
4. Attach the other end of this wire to the switch.
