NABCO ENTRANCES TECHNICAL BULLETIN

Date: Jan 9, 2017

Sensor Monitoring Problem with BEA IXIO DT1 and Optex OS-12C T Beam controller

Bulletin Number: **78**

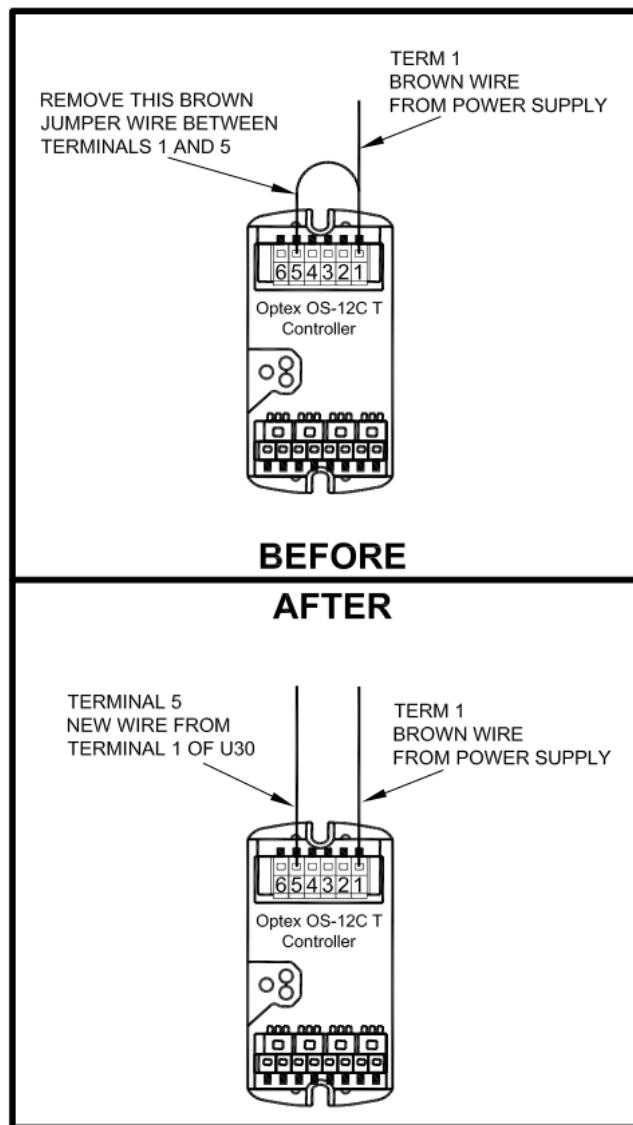
Once the system is powered up, the Optex holding beam controller stops working (red and green LED's are off) and the door holds open.

When the BEA IXIO DT1 sensor is used with the Optex controller and the monitoring voltage levels to each device are different, because of the internal circuitry of the IXIO, the separate voltages are allowed to mix causing the Optex beam controller to stay on.

Remove the brown jumper wire that connects terminals 1 and 5 on the Optex OS-12C T beam controller. Then run a new wire from terminal 5 on the beam controller to terminal 1 on the U30 control. Nothing else needs to be done.

1. At this time we are only aware of this occurring when power is first applied to the unit after Installation.
2. All sliders currently being shipped from our factory have a modified harness on the GT1175 so that all monitoring voltage signals originate directly from the U30.
