TECHNICAL BULLETIN

Date: July 25, 2018

## Software Glitch on GT20

Bulletin Number: 96

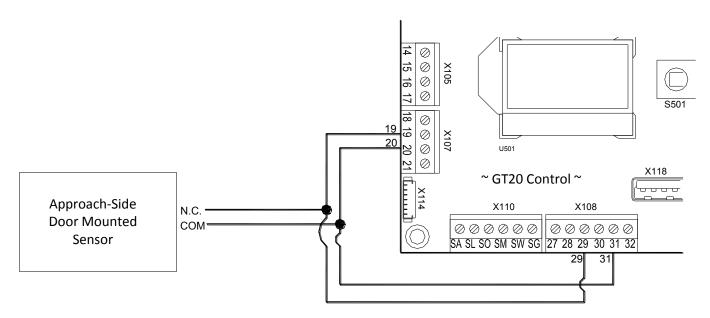
It has come to our attention that the GT20 has a software issue related to push side door mounted sensors.

If a door mounted sensor is installed on the push side of the door and the sensor is in detection, the door will not activate from either the sensor or another source such as a wall switch. Once sensor detection ceases, the door will open from an alternate activation. To our understanding this only pertains to the latest software release V01.02.20.

Refer to the illustration below. If you encounter this problem, the workaround is to parallel the lock output to the safety input by installing jumpers between terminals 19 & 20 and 29 & 31. This will resolve the problem until a new software update becomes available.

- 1. Under "config",
- 2. "Unlock" must be set to "Perman".
- 3. "LockAU, "LockEX", and "LockMA" must all be set to "Lock".

The above diagram uses the electric lock output to resolve the problem. If the lock output isn't available, then a door-position switch would be needed to provide a closed contact into terminals 19 and 20 when the door is closed.
