| Date<br>1/17/2025 | Bulletin #<br>126 | Model<br>Nabco Swing (GT630) |
| Subject<br>Header Installation | | |

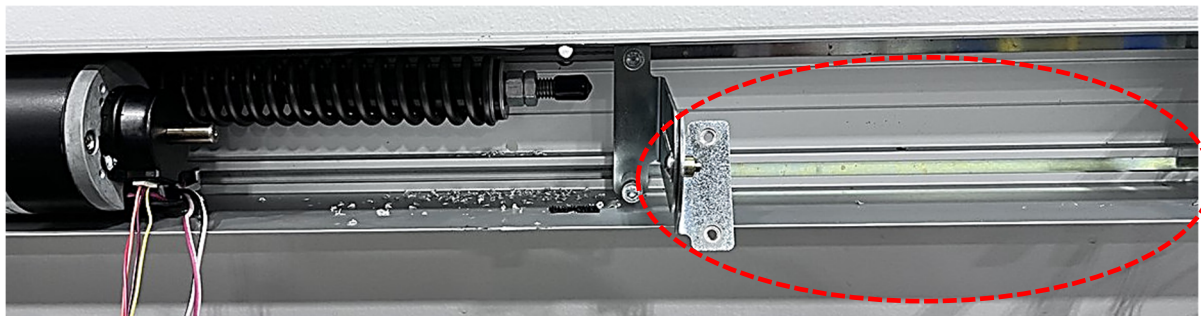
- Holes for mounting the header may need to be drilled during installation. Metal shavings from the drilling process may fall onto the Opus control or behind the clear plastic cover. This can cause the Opus control to become inoperable.

- Nabco recommends during the install process of the header, one of two things can be done to prevent metal shavings from damaging the Opus control.
  - The Opus control can be removed from the brackets that secure it to the header prior to the drilling/installation of the header.
